Manhole Inspection Summary

Manhole # S49M__003MH

Insp Date: **4/16/08 9:34 AM**

Location Address: **rear 2511 fait ave**

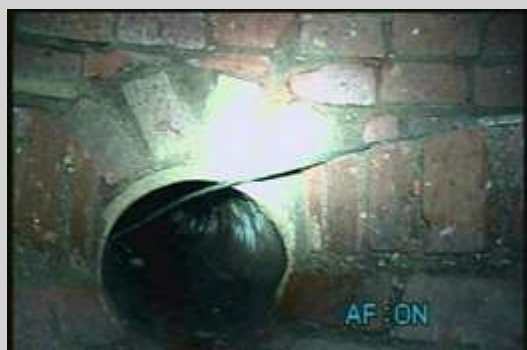
12 O'Clock Outflow

8 in. Circular Gravity Sewer
Pipe Out @ 12 O'Clock

Pipe Material: **Clay** ☐ Pipe Lined

Invert Depth: **9.75** (ft.) Flow Characteristics: **None**

Deposits: ☒ None ☐ Mud ☐ Sludge ☐ Debris ☐ Grease

Infiltration: **None** Pipe Seal Cond: **Unknown**

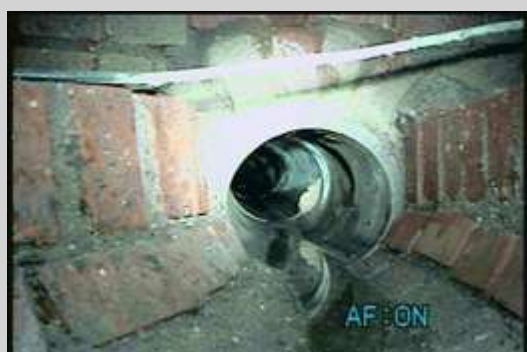
3 O'Clock Inflow

8 in. Circular Gravity Sewer
Pipe In @ 3 O'Clock

Pipe Material: **Clay** ☐ Pipe Lined

Invert Depth: **9.35** (ft.) Flow Characteristics: **Slow**

Deposits: ☒ None ☐ Mud ☐ Sludge ☐ Debris ☐ Grease

Infiltration: **None** Pipe Seal Cond: **Unknown**

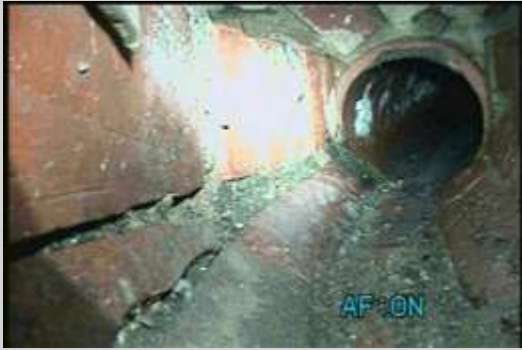
7 O'Clock Inflow

Pipe In @ 7 O'Clock

Pipe Material: **Clay** ☐ Pipe Lined

Invert Depth: **9.10** (ft.) Flow Characteristics: **None**

Deposits: ☒ None ☐ Mud ☐ Sludge ☐ Debris ☐ Grease

Infiltration: **None**

Connects To: **House connection / Service line**

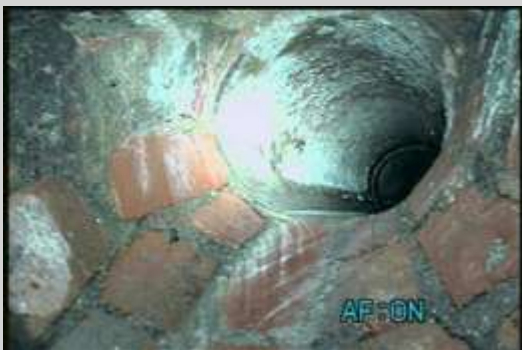
9 O'Clock Inflow

Pipe In @ 9 O'Clock

Pipe Material: **Clay** ☐ Pipe Lined

Infiltration: **None**
